From: Flock Safety Support
To: Stephen Best
Cc: brendon.norton@flocksafety.com; Tee Jane Teh; libby.landers@flocksafety.com; Eligio Lara; Daniel Cohen; Stephen Best; jake.sherman@flocksafety.com; Michael Balcorta
Subject: RE: Cam 086 "SB Bradley (north of Hancock)" still fail to read
Date: Thursday, May 30, 2024 11:32:04 AM

---------- Original Message ----------
From: Stephen Best [sbest@cityofsantamaria.org]
Sent: 5/30/2024, 9:07 AM
To: libby.landers@flocksafety.com; support@flocksafety.com; jake.sherman@flocksafety.com; brendon.norton@flocksafety.com
Cc: elara@cityofsantamaria.org; dcohen@cityofsantamaria.org; sbest@cityofsantamaria.org; mbalcorta@cityofsantamaria.org; tteh@cityofsantamaria.org
Subject: Cam 086 "SB Bradley (north of Hancock)" still fail to read

Camera “086 SB Bradley (north of Hancock)” has been having problems reading plates at night.

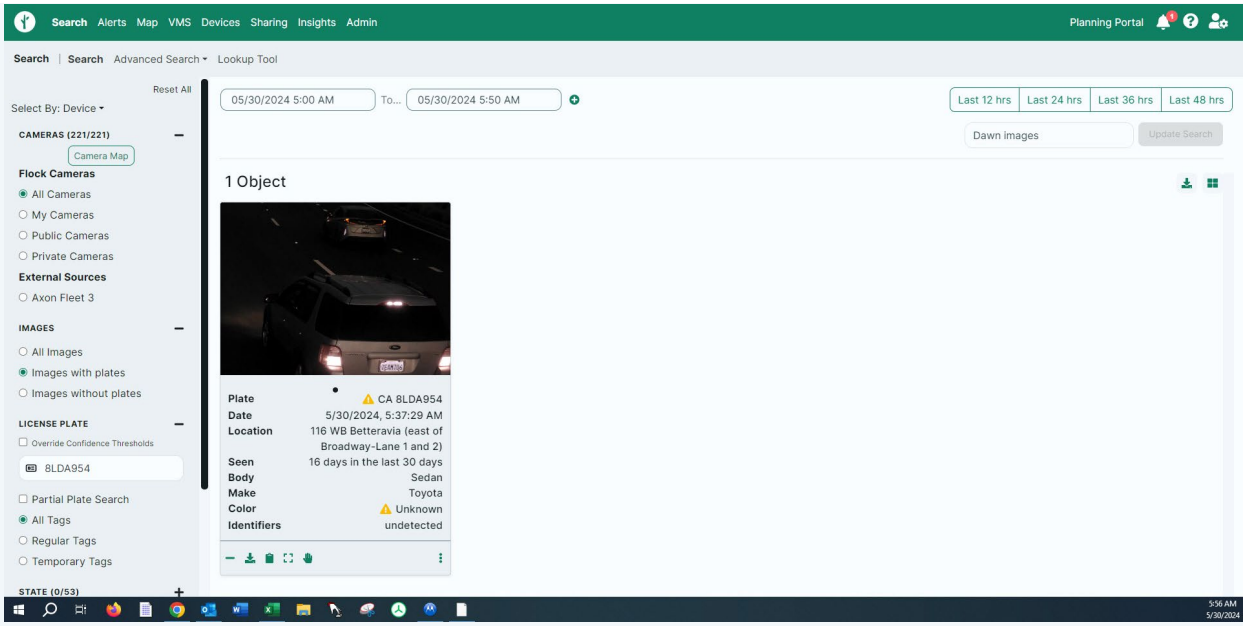
This morning (dawn…not really dark at all), I drove past the camera at 05:35:15 Hrs. in the #1 lane and the camera failed to record my plate (or my vehicle).

It DID record the pickup truck which was in the #2 lane behind me about 100 yards (about 2 seconds later).

Attached is the documentation.

Please continue to work on this camera.
